A review of four on-farm water supply demonstration farms

M H M Casey

A Review of Four On-Farm Water Supply Demonstration Farms

Resource Management Technical Report No.120

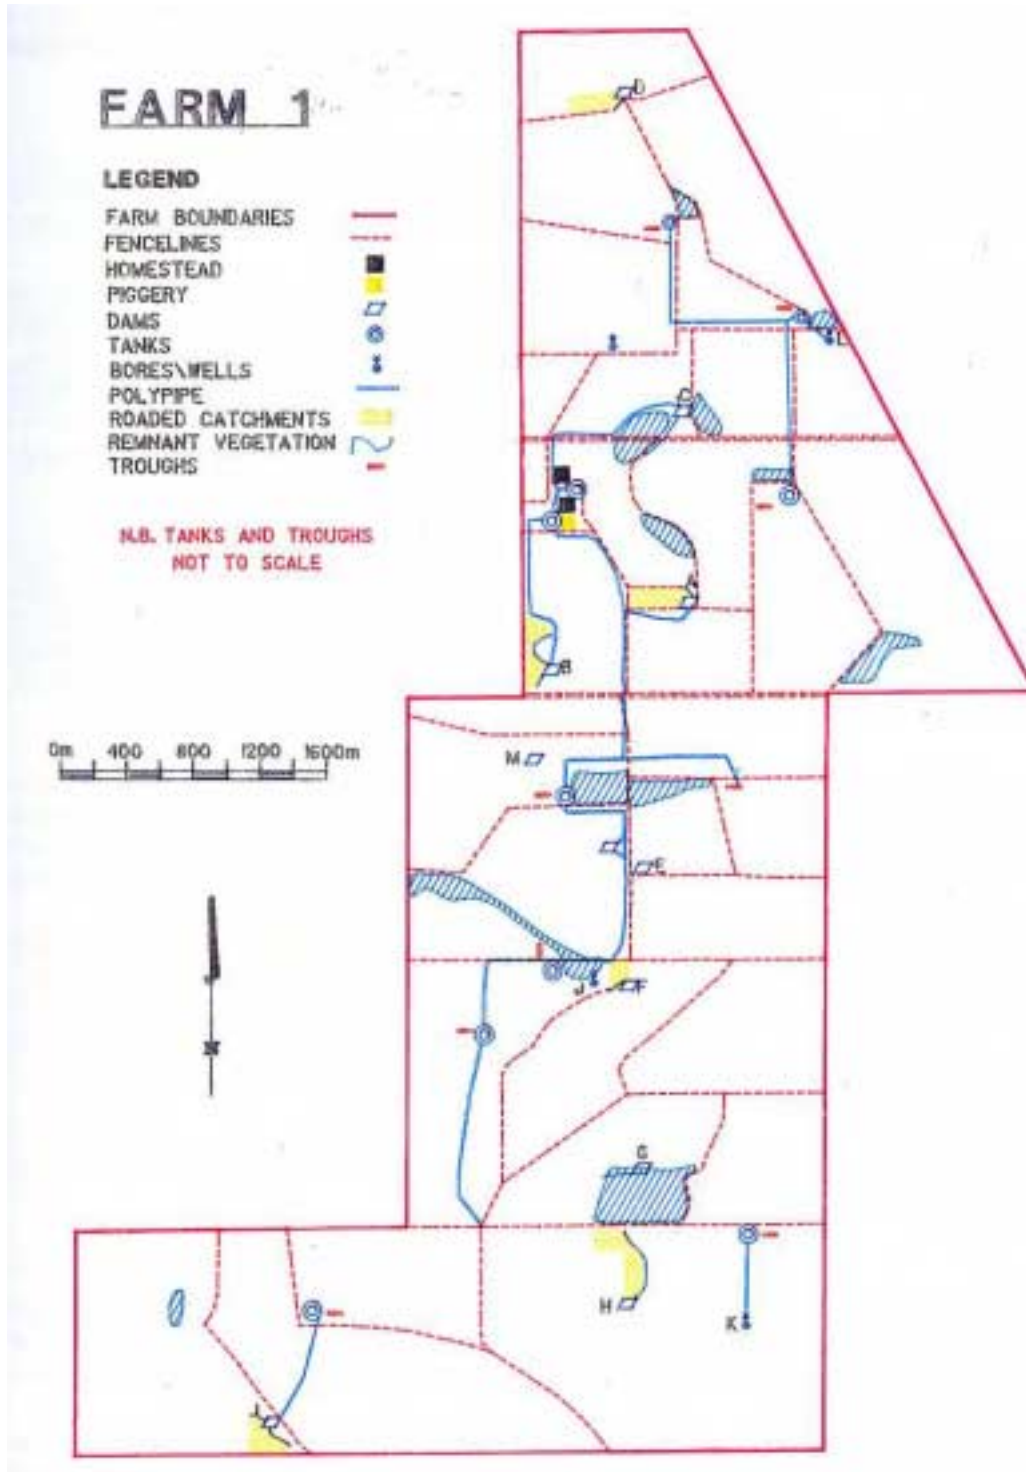
Figure 4. Farm 1 - Farm Plan.

The following aspects of the project require special comment. One proposed roaded catchment was not constructed (on Dam M), thereby limiting supply; and the smaller dams with no improved catchments (in particular, Dams E, G and M) can only cater for a small demand.

Although the water level in the "key" supply (Dam B in Figure 4) was low, sufficient water for more than four weeks supply remained at mid-March, when widespread storms caused significant runoff and replenished the water source in all dams. No water has been carted since 1983.

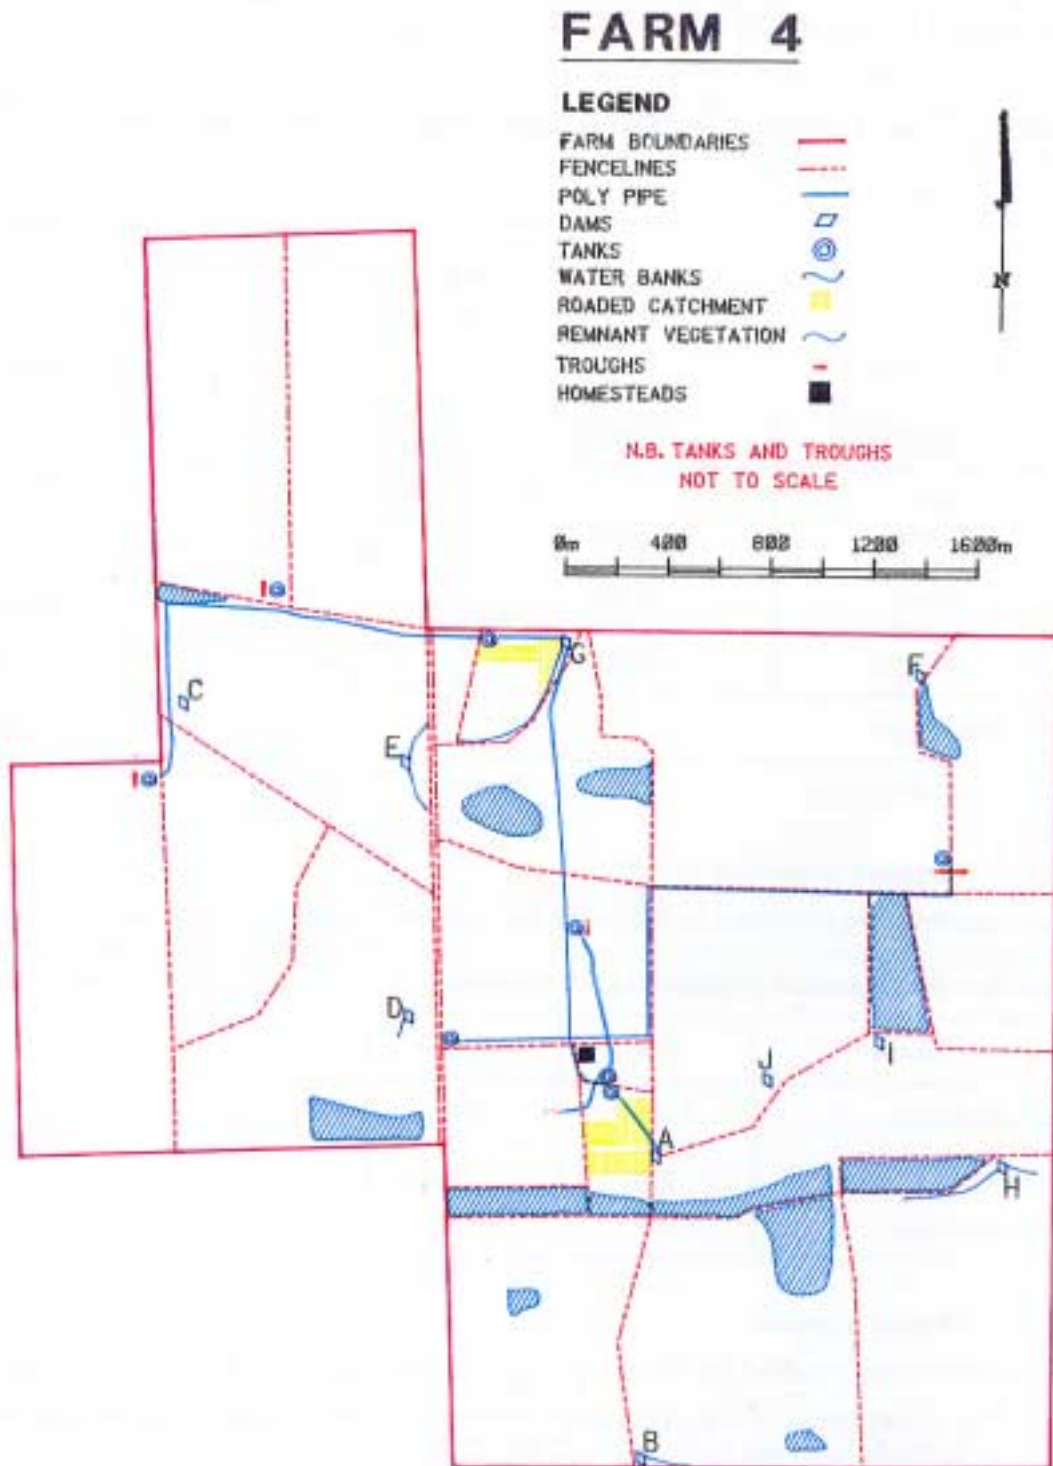
Figure 10. FARM 4 - Farm Plan.

The dam water is not treated before being used on the garden. However, where the water from the reticulation system falls on the fruit trees, the leaves have died indicating that the fruit trees are highly sensitive to turbid water. It seems likely that clay suspended in irrigation water can clog the pores of the leaves, not allowing them to transpire. The dam water does not seem to affect the lawn or pot plants. Water for the garden is pumped from Dams A and G (Figure 10), usually from Dam A first.
