A review of four on-farm water supply demonstration farms

M H M Casey

A Review of Four On-Farm Water Supply Demonstration Farms

Resource Management Technical Report No.120

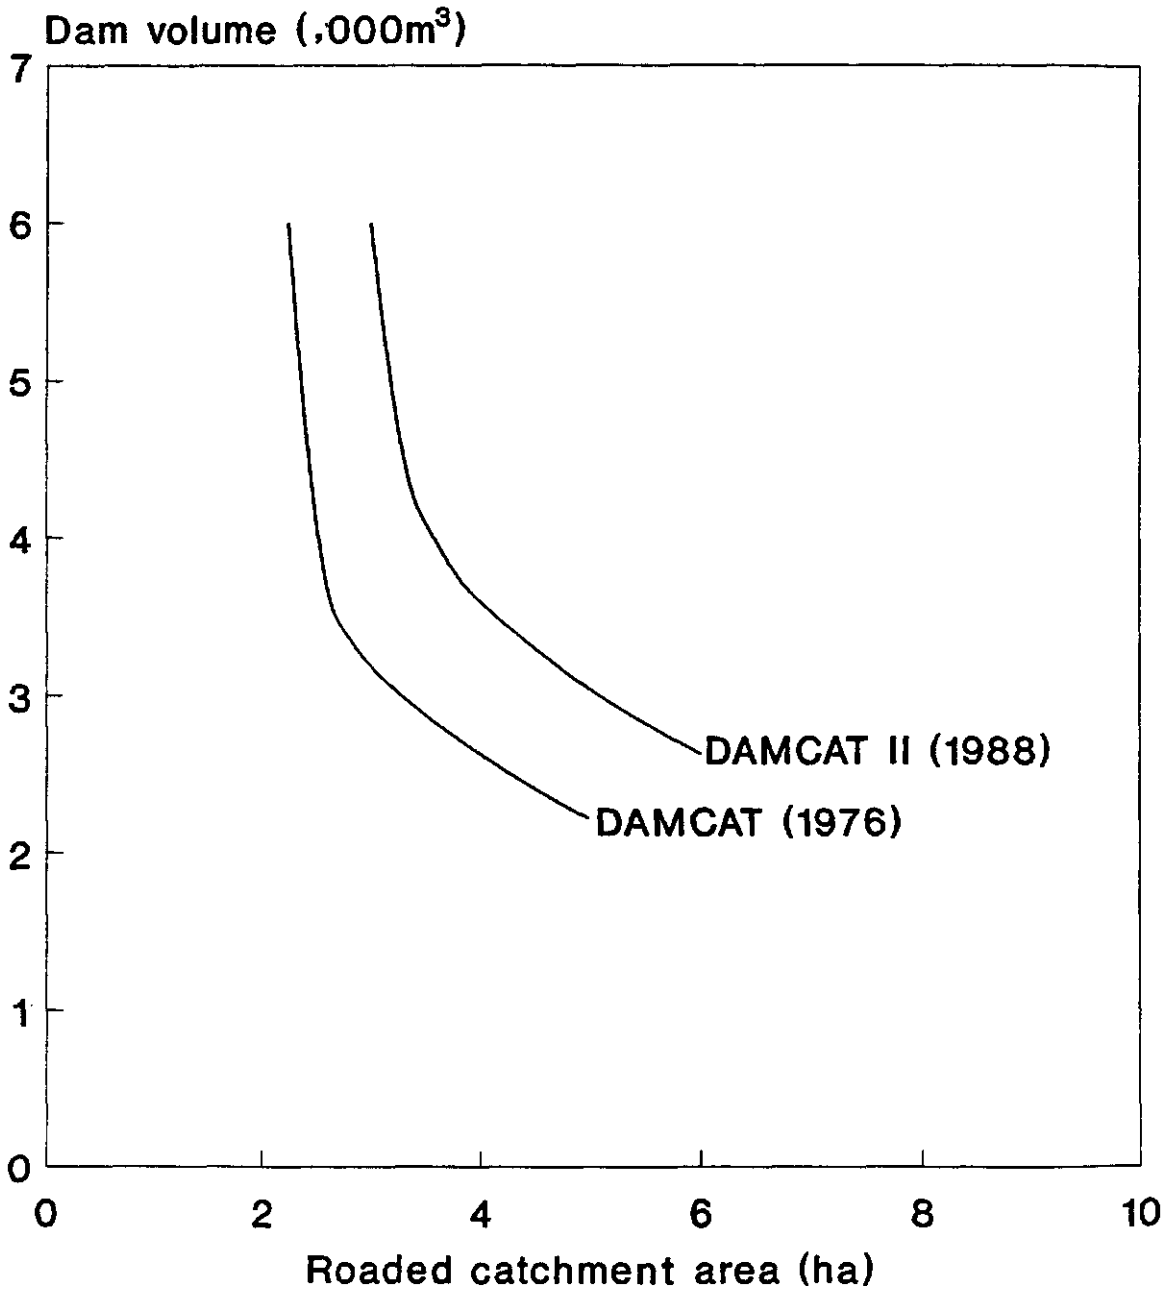
Figure 12. Relationship between DAMCAT (1976) and DAMCATII (1988).

As DAMCAT (1976) allocated a higher DSE rating to dams than DAMCATII (1988) (Figure 12), a review of the four demonstration farms based on DAMCAT n (1988) will inevitably indicate a design short-fall. Farm 1 and Farm 2 are now classed as potentially water deficient because their present demand is greater than the present supply. However, water for livestock use was carted onto only one of the four farms (Farm 4) for a six-week period in the nine-year period from 1983 to 1992.
