Evaluation of deep, open drains in the North Stirling area

Evaluation of Deep, Open Drains in the North Stirling Area

Resource Management Technical Report 161

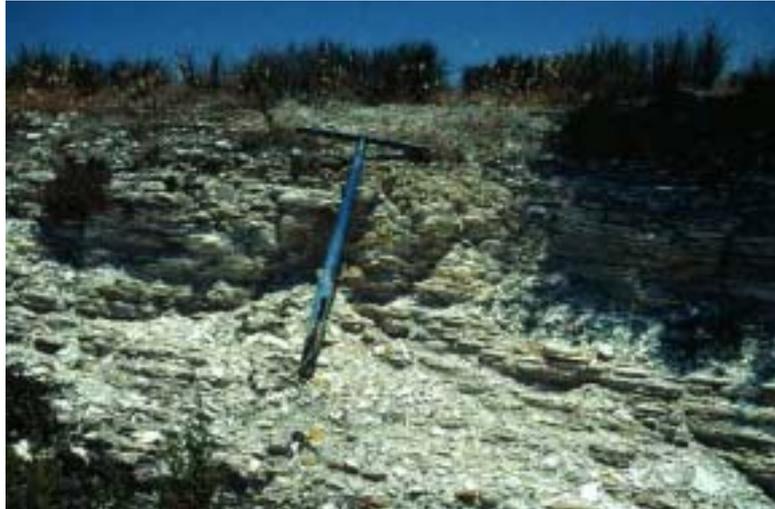
Photo 1: Sedimentary layers of the Pallinup silty clay in the study area.

The area is covered by Pallinup Siltstone which is a Tertiary Formation. The Pallinup sediments in this area, are mainly composed of fine silt, clay (Photograph 1) and occasionally fine to medium sand (Table 1). The siltstone, in some areas, contains pink and white spongolite (a siltstone full of sponge spicules). The Pallinup Siltstone overlays the basement rock which is of Precambrian origin and part of the Yilgarn Craton. There are basement (granite and gneiss) highs in the area that are covered by sediments. Weathered granite can be seen along the bed of the main drain (Figure 1).

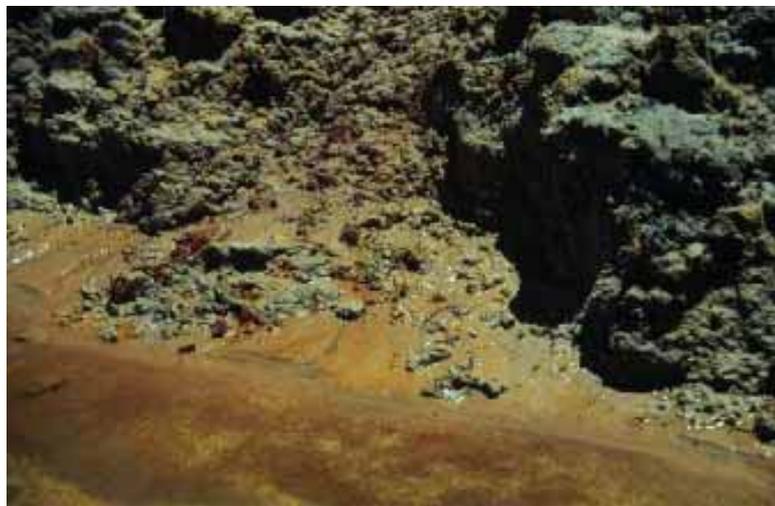
Photo 2: One of the few major seepage zones. Note: the collapse of material at the seepage zone which is in the centre of the photograph.

We recorded the position of major seepage zones (Figure 1 and Photograph 2) which were along the mid section of the drain.

1. Sub-soils, along the drain, are mostly silty clay and occasionally (at discharge sites) fine to medium sand.
2. * = There were some mottles in that depth interval.
3. @ = Photograph 2 shows photo of this site.
4. # = Photograph 3 shows photo of this site.

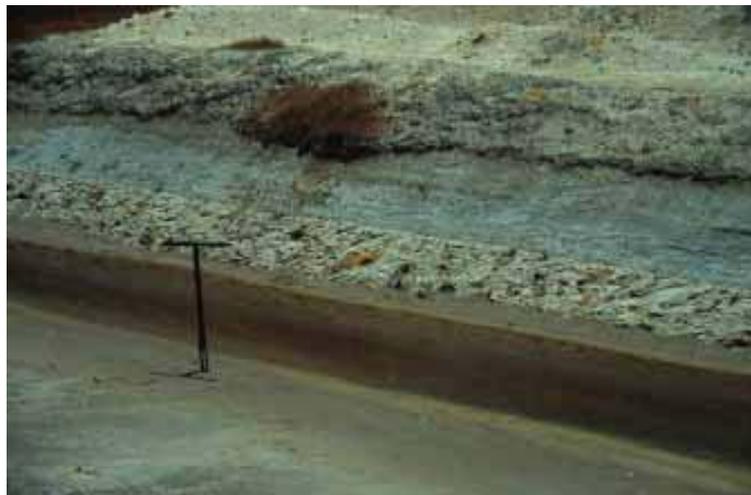
Photo 3: With the exception of a few sites, the soil profile along the main drain is very tight silty clay. Note: The bed of the drain is filled with silt.

Some sections of the main drain were badly eroded. Gullies, 1 m apart and up to 0.5 m deep, had formed along the sideslopes in some sections of the main drain (Photograph 4). Part of the eroded material had filled the base of the main drain (Photograph 3) and part was transported out of the area. There were also indications of sedimentation further downstream. A typical site where this silting may be seen is 500 m before the creek crosses the South Formby Road (Figure 1). On the 1985 aerial photographs there are four pools in this area. These pools are absent on the 1993 aerial photographs. It is likely that these pools have been filled with silt between 1985 and 1993. Silting of the creek bed can also be seen further downstream, east of the South Formby Road.

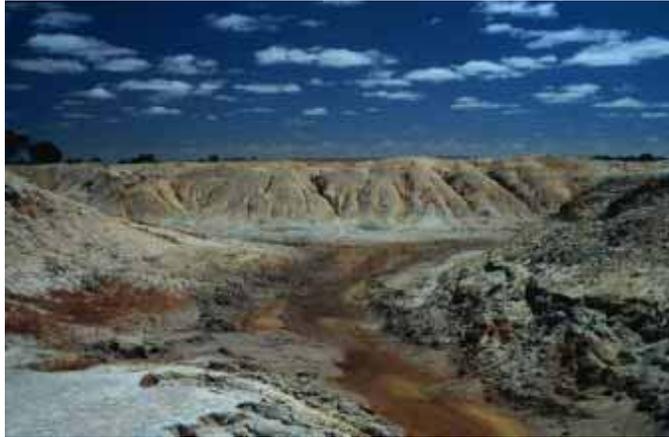
Photo 4: The slopes of the main drain are badly eroded.

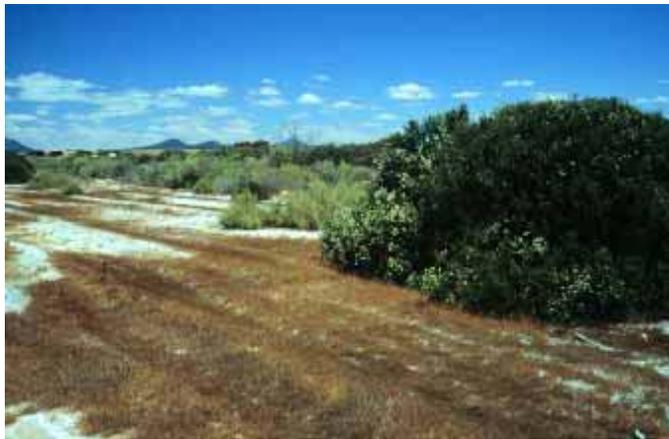
Photo 5: Melaleuca thuyoides (foreground) had more impressive growth than Atriplex spp. (saltbush).

Improvement of creek beds and flood plains (eg. Area 2; Figure 3) could be partly attributed to them being fenced off and revegetated with salt-tolerant species. These areas had been mounded and planted with salt-tolerant species. *Melaleuca thyoides*, *Acacia saligna* and *Atriplex spp.* were among the surviving plants. *Melaleuca thyoides* was very impressive (Photograph 5) with a large canopy (5m in diameters) and healthy growth.

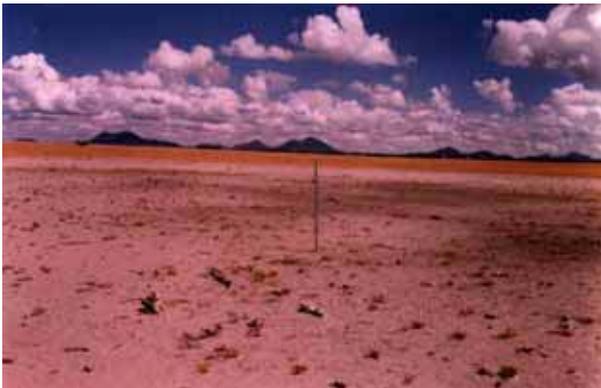
Photo 6a : This area was extremely salt-affected and bare in April 1985.

The improved area, furthest from the drain which was cropped in 1996 was a 3 ha patch of land (Area 3; Figure 3) up to 200 m away from the main drain. Improvement of this land is entirely due to the effects of the drain since there is no treatment other than the drain. The area was bare in 1985 (Photograph 6a). At the time of our second visit (December 1996), this area had been cropped but not harvested because the crop (barley) looked patchy. The Geonic EM38 readings on this area were between 80 and 120mS/m. These reading showed that the area was still moderately salt-affected. Photograph 6b shows lupins grown in the area in 1995. This land is probably on a sandy lens that crosses the deep drain (Site S1; Figure 1). By having a high hydraulic conductivity, this sandy lens has extended the effect of the drain far beyond the expected distance. We observed one section (Site S1; Figure 1) of the deep drain that had higher seepage rates than other areas and found that the sandy lens crossed the drain here.

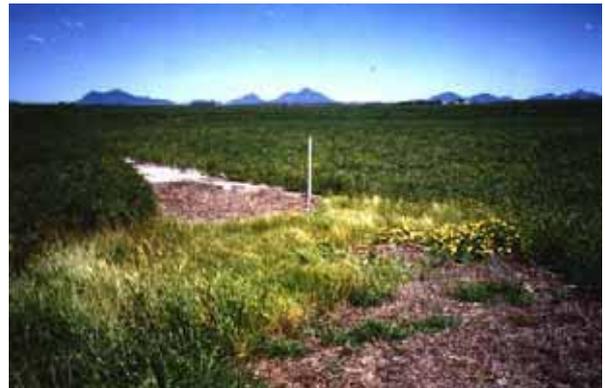
Photo 6b: The same area in September 1995 growing a crop of lupins.
