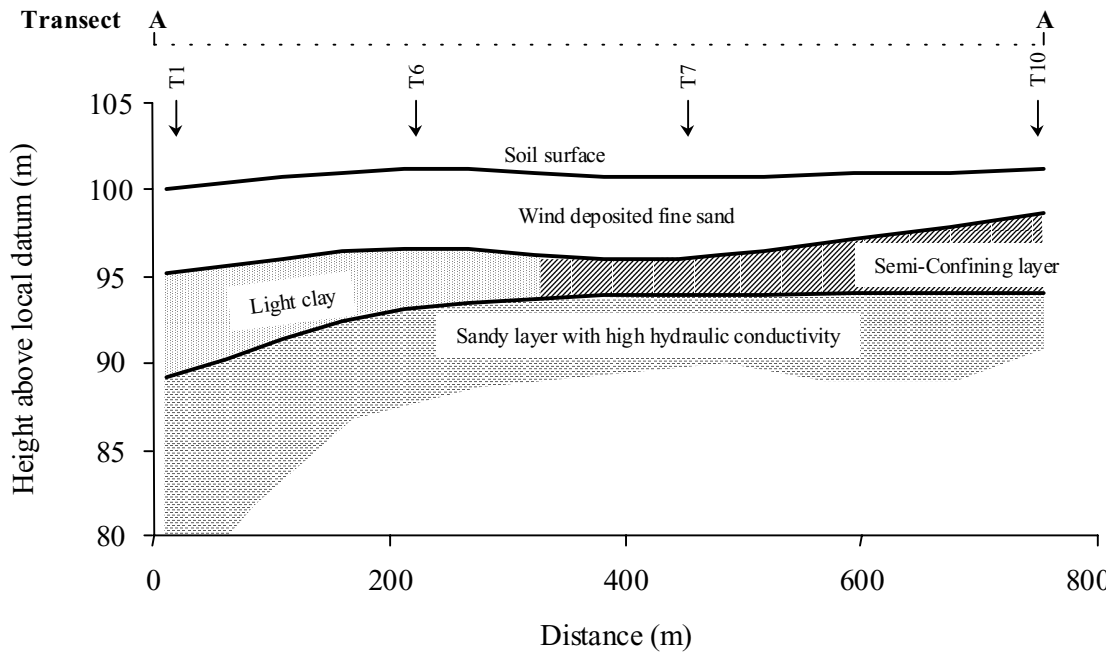
Figure 8a: This east-west cross section is north of town and shows that there is a sandy layer at depth that has high hydraulic conductivity

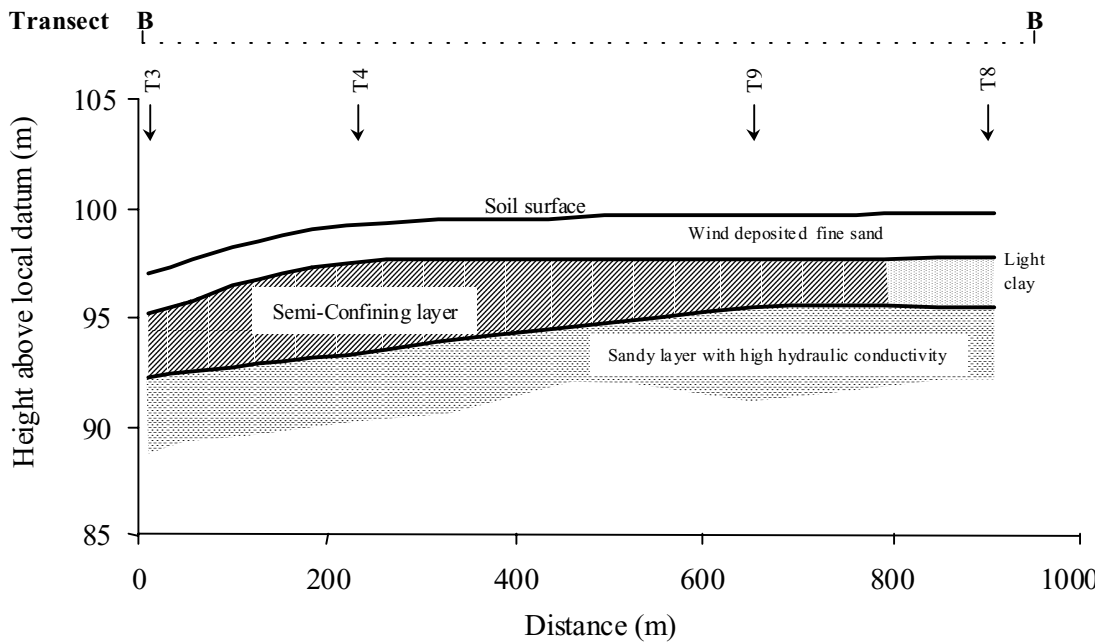
Figure 8b: This east-west cross section which passes through centre of town, shows a sandy layer at depth and a semi-confining layer above it

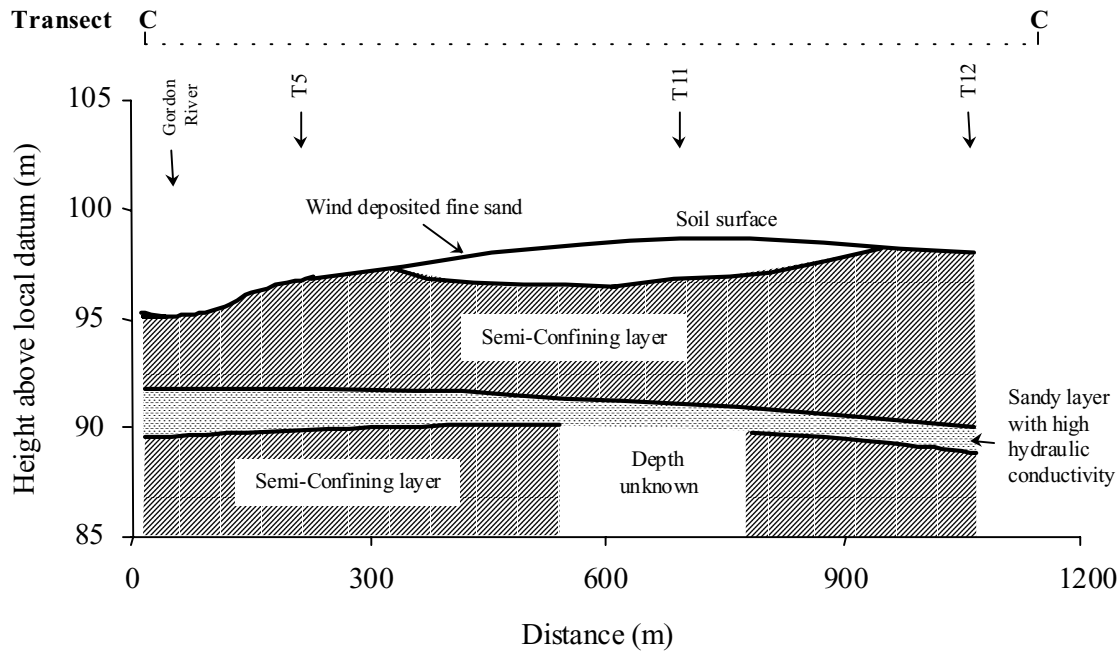
Figure 8c: This east-west cross section passes through southern parts of town and shows a sandy layer at depth, a semi-confining layer above it and limited areas in the town centre that has wind deposited fine sand.

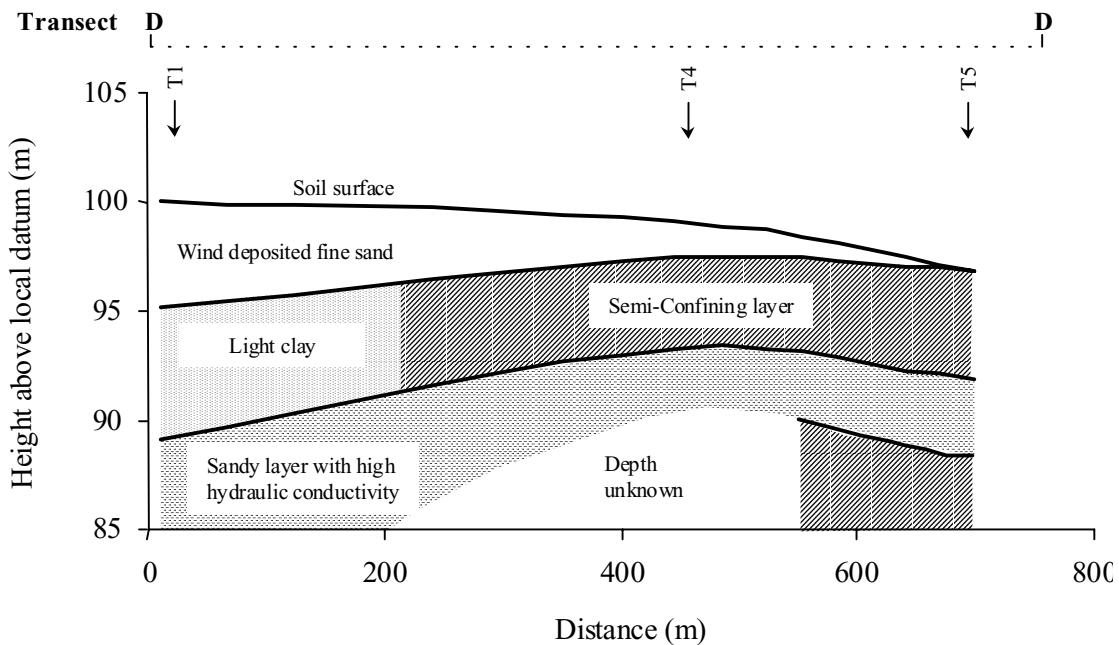
Figure 8d: This north-south cross section passes along the highway and shows a sandy layer at depth, a semi-confining layer above it and wind deposited fine sand which is deeper in the north and shallower or non-existent in the south
