A review of four on-farm water supply demonstration farms

M H M Casey

A Review of Four On-Farm Water Supply Demonstration Farms

Resource Management Technical Report No.120

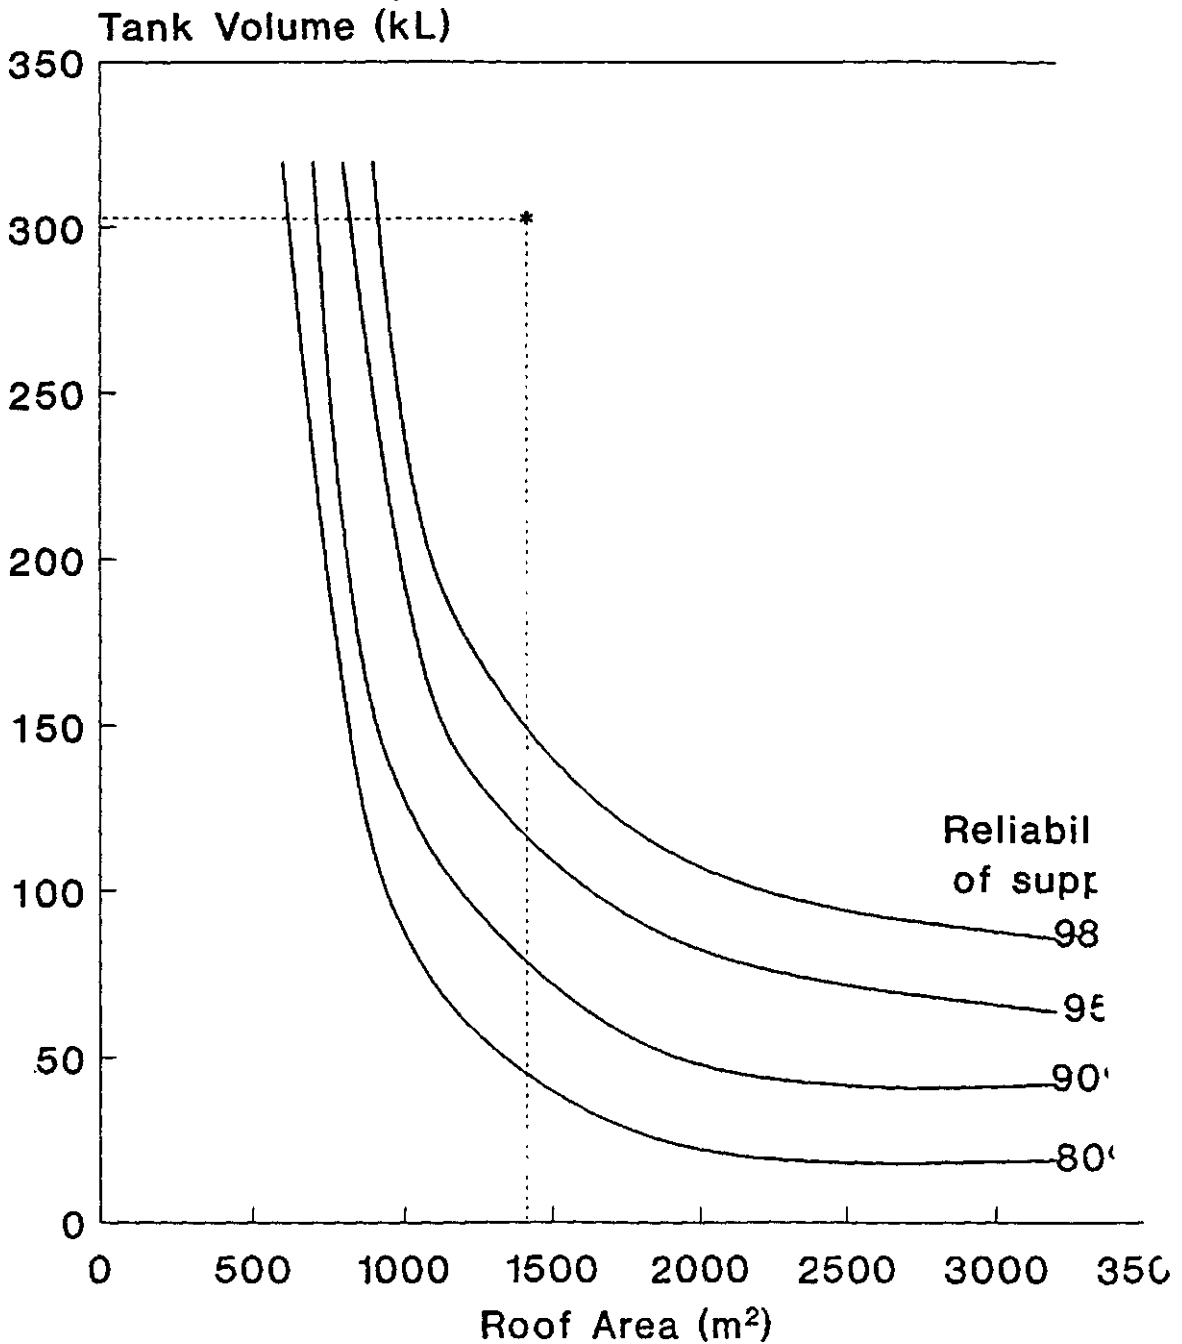
Figure 5. Raintank curves - Farm 1.

RAINTANK (Laing et al. 1988) Indicates that there should be greater than 98 per cent reliability for the domestic water supply if the daily demand averages 800 L for the houses (Figure 5). When the domestic water is in short supply, dam water is used in the toilet and for the shower. The dam water is treated with lime to settle suspended clay before it is pumped from a 90 kL tank which normally stores dam water for the garden.

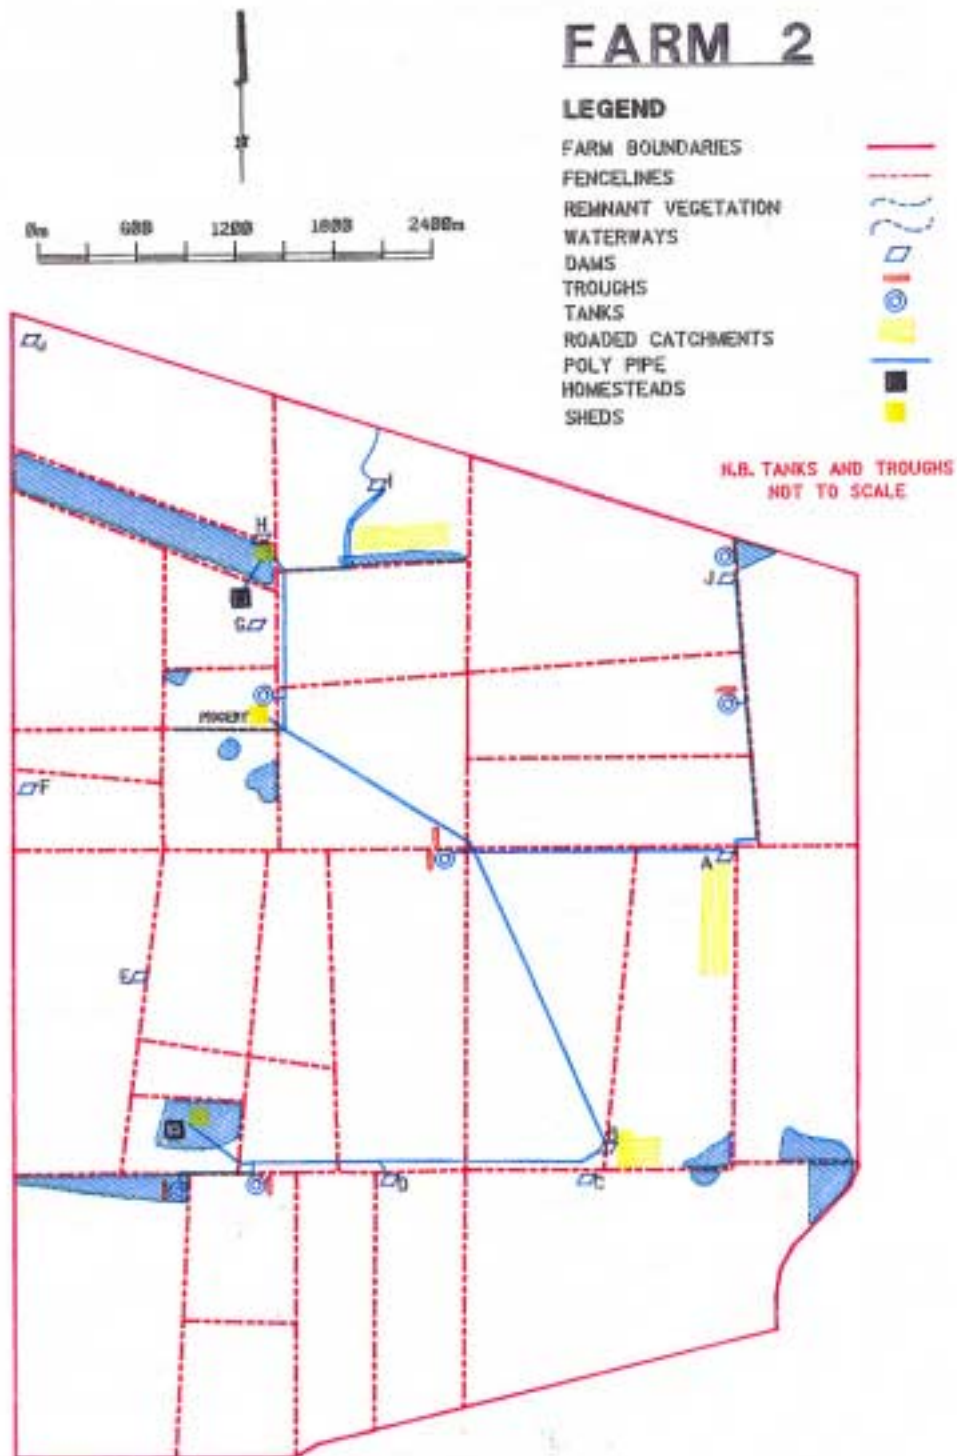
Figure 6. FARM 2 - Farm Plan.

Piggery washdown and drinking water, used in a ratio of 12:1, totals 4,800 kL annually or 13.2 kL per day. This water is pumped from dams B and A (Figure 6). The farmer believes that because of his increased water supply, he could house up to 1,000 pigs.

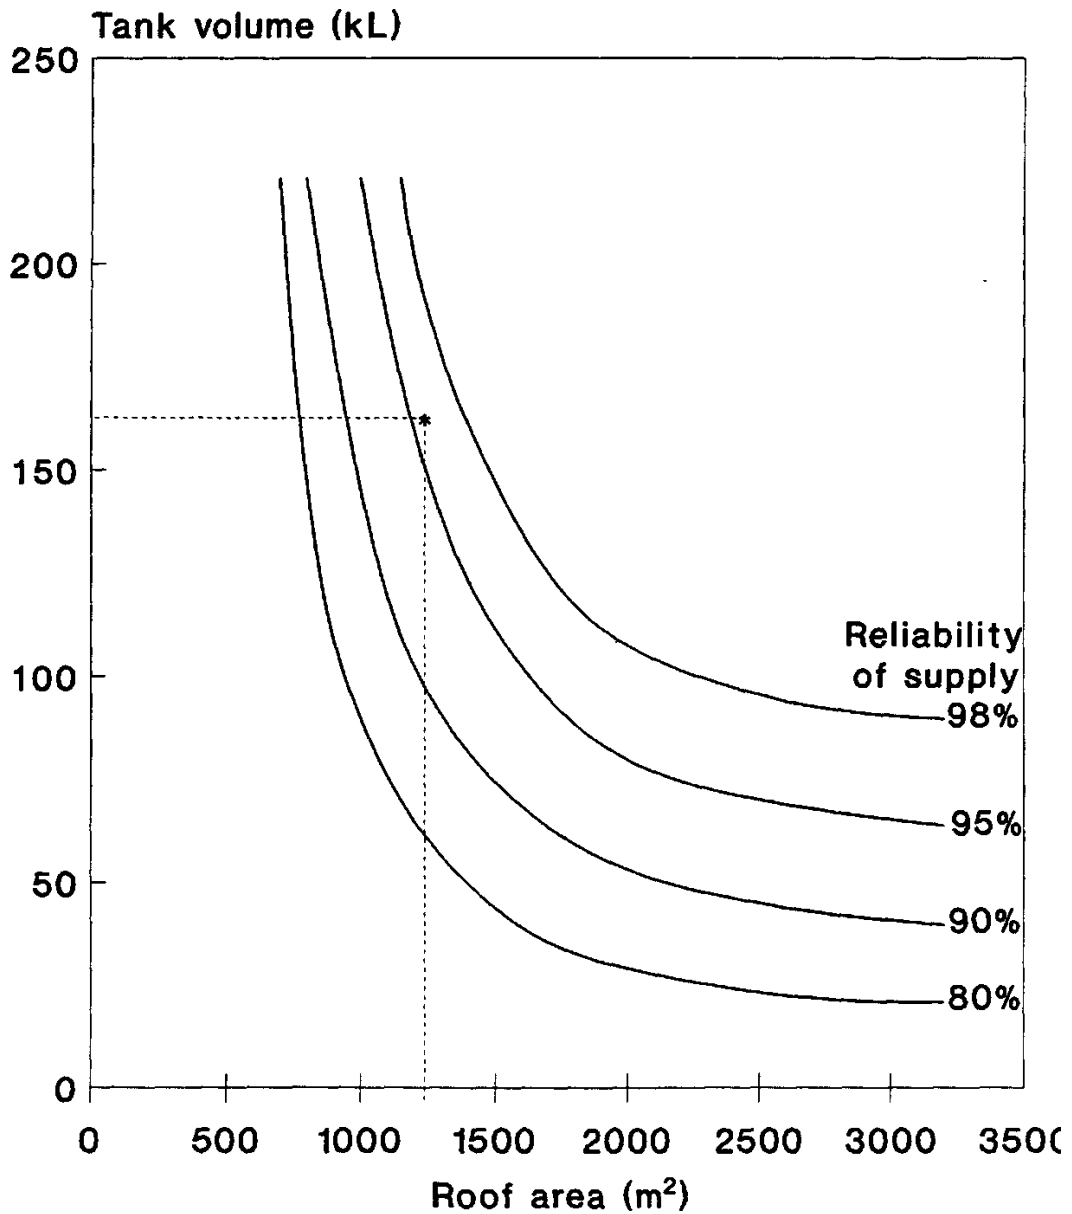
Figure 9. Rain tank curve – Farm 3.

Presently 1,190 m² of roof area is connected to tanks to collect rainwater. Total tank volume is about 164 kL. Using the RAINANK computer simulation model for a demand of 800 L per day, the domestic water supply should be 97 per cent reliable (Figure 9). However, since the new water supplies were implemented, the farmer has not had to cart water for domestic use.

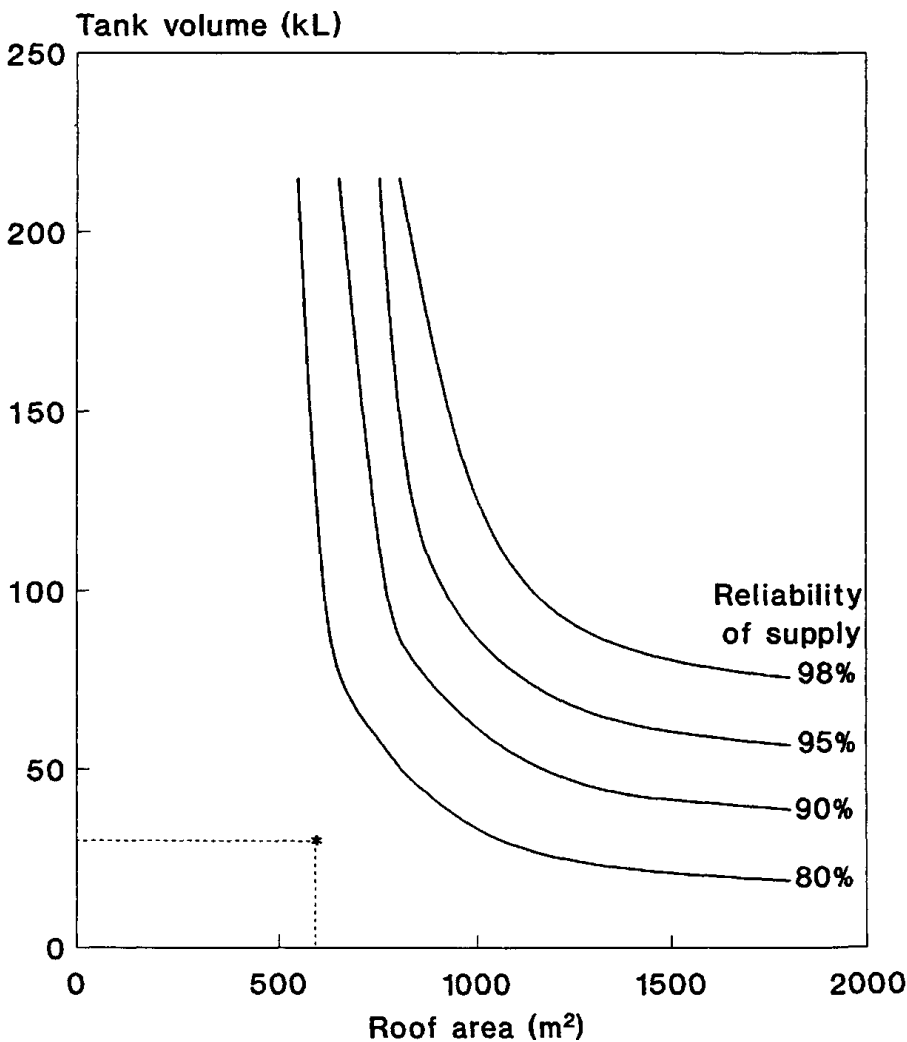
Figure 11. RRAINTANK curve - Farm 4.

The total roof area connected to tanks to collect rainwater for in-house use is 600 m². Tank volume is 28.3 kL. With the demand being 600 L per day, RAINTANK indicates less than 80 per cent reliability of supply (Figure 11). This is supported by the fact that the farmer carts water nearly every year in the summer months.

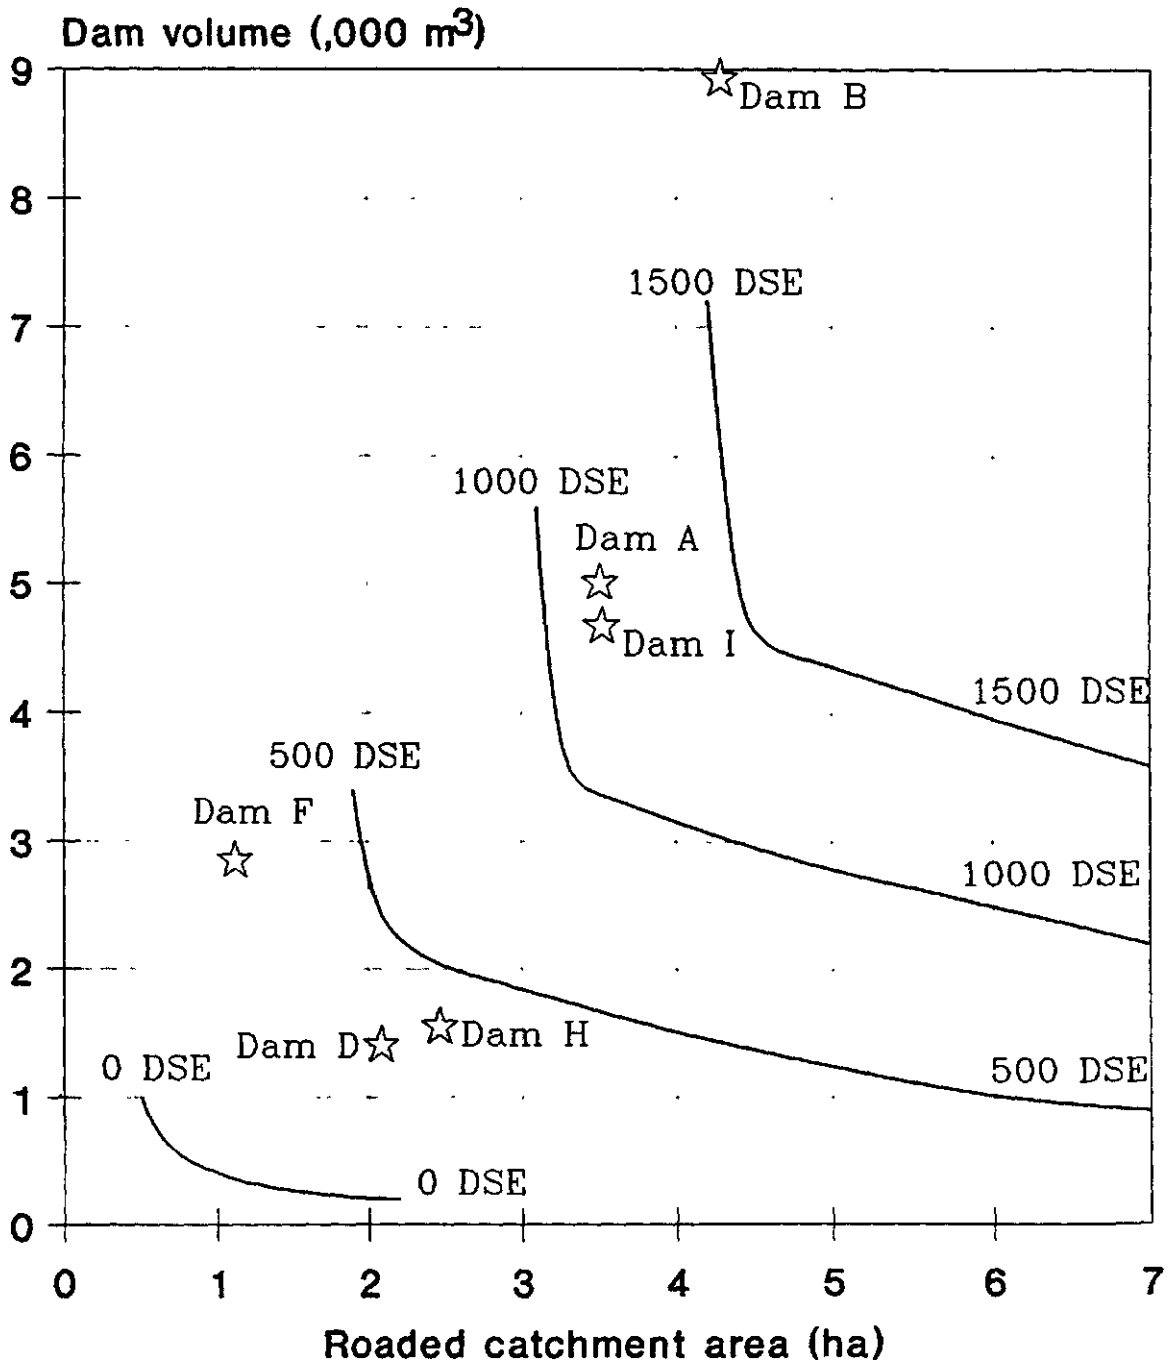
Figure 13. DSE values of dams and roaded catchments on Farm 1.

As DAMCAT (1976) allocated a higher DSE rating to dams than DAMCATII (1988) (Figure 12), a review of the four demonstration farms based on DAMCAT n (1988) will inevitably indicate a design short-fall. Farm 1 and Farm 2 are now classed as potentially water deficient because their present demand is greater than the present supply. However, water for livestock use was carted onto only one of the four farms (Farm 4) for a six-week period in the nine-year period from 1983 to 1992.

Figure 12 shows how DAMCAT (1976) and DAMCAT II (1988) compare. As an example, dam sizes and associated roaded catchments for Farm 1 were plotted in the DAMCAT n (1988) graph (Figure 13). The number of DSE's the dam can cater for without going dry can be estimated from the set demand levels on the graph.

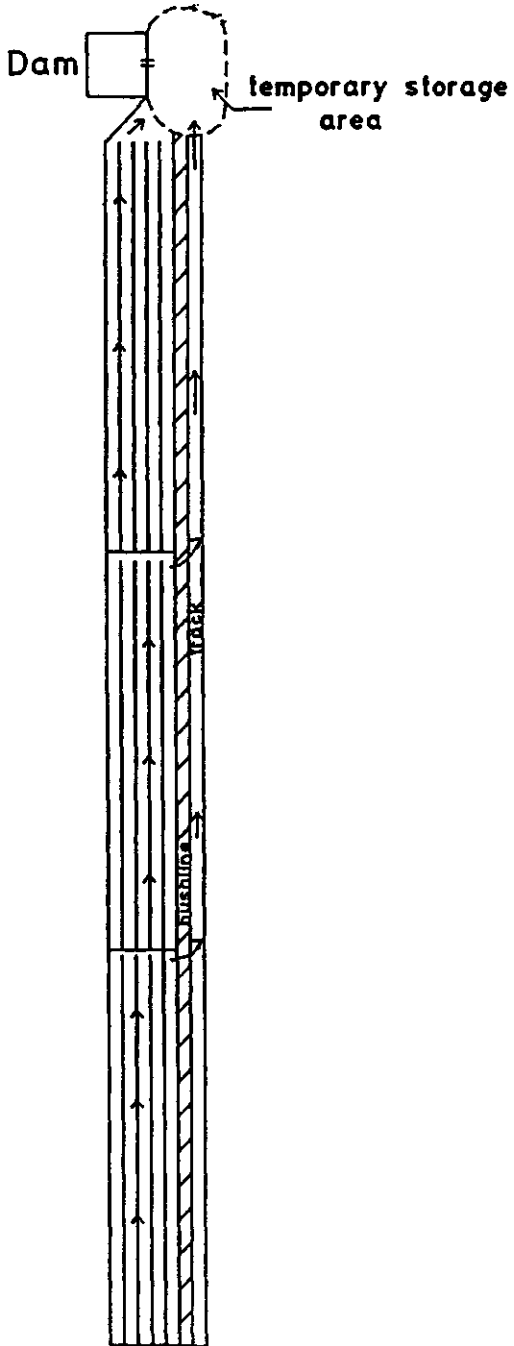
Figure 15. Plan view of a dam and roaded catchment design (Farm 2).

Roaded catchments on the demonstration farms commonly have the roads running straight downhill. These can erode if the natural slopes, and therefore the roads, are too steep. Plan views of two dam and catchment combinations are presented in Figures 14 and 15, as examples of roaded catchment layout. One roaded catchment on Farm 3 has suffered serious erosion due to the combined effects of steep channel slopes (up to 3 per cent), and dispersive soils. The overall gradient on the roaded catchment is 1.1 per cent, for 500 m. The gradient is steepest at the end of the roaded catchment furthest from the dam.
