A review of four on-farm water supply demonstration farms

M H M Casey

A Review of Four On-Farm Water Supply Demonstration Farms

Resource Management Technical Report No.120

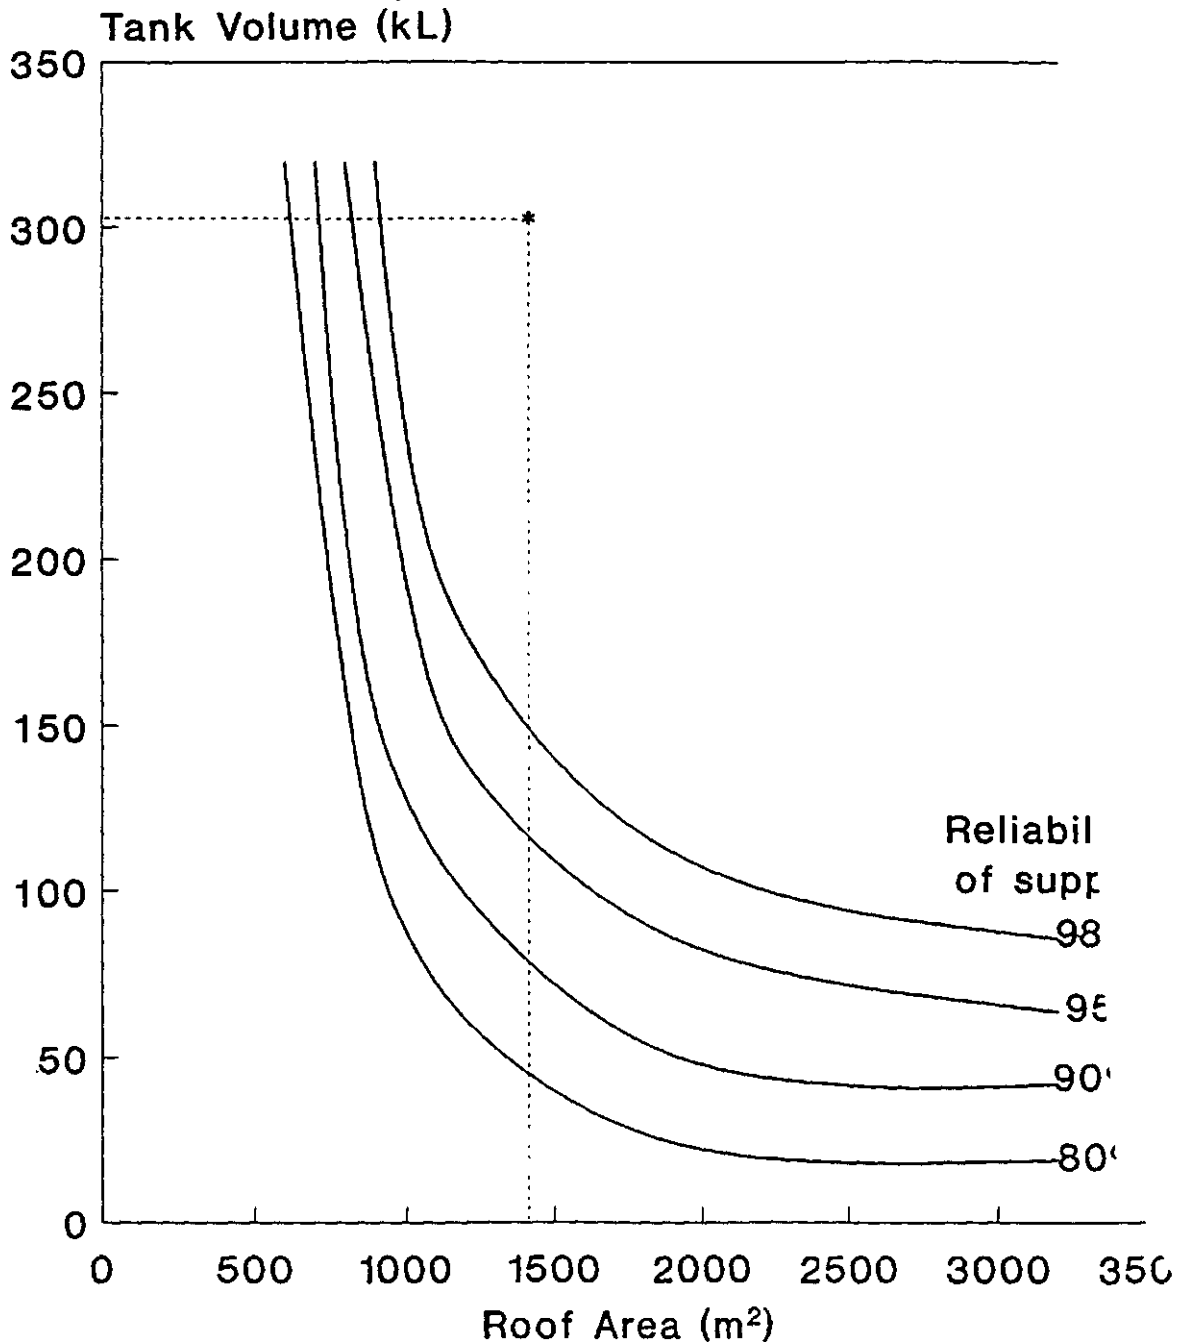
Figure 5. Raintank curves - Farm 1.

RAINTANK (Laing et al. 1988) Indicates that there should be greater than 98 per cent reliability for the domestic water supply if the daily demand averages 800 L for the houses (Figure 5). When the domestic water is in short supply, dam water is used in the toilet and for the shower. The dam water is treated with lime to settle suspended clay before it is pumped from a 90 kL tank which normally stores dam water for the garden.

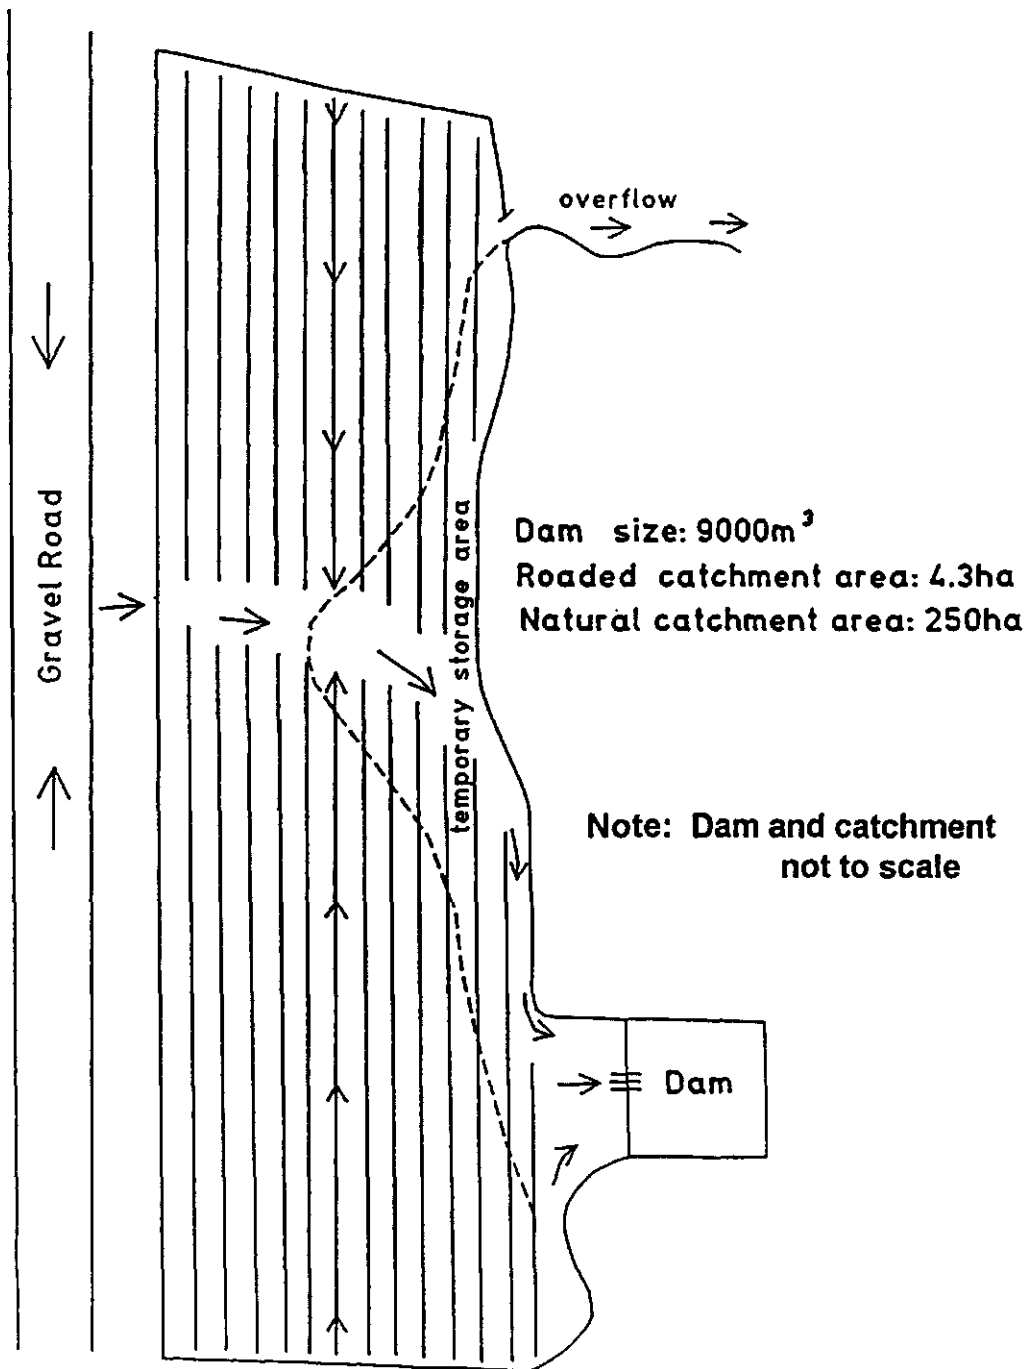
Figure 14. Plan review of a dam and roaded catchment design (Farm 1).

Roaded catchments on the demonstration farms commonly have the roads running straight downhill. These can erode if the natural slopes, and therefore the roads, are too steep. Plan views of two dam and catchment combinations are presented in Figures 14 and 15, as examples of roaded catchment layout. One roaded catchment on Farm 3 has suffered serious erosion due to the combined effects of steep channel slopes (up to 3 per cent), and dispersive soils. The overall gradient on the roaded catchment is 1.1 per cent, for 500 m. The gradient is steepest at the end of the roaded catchment furthest from the dam.
